Review Committee Report on the
Fatal Accident Involving *Imedi*
During the 2018 Chicago Yacht Club Race to Mackinac
on July 21, 2018
Published: February 25, 2019

Committee Members: Christopher Thomas, chair, Nick Berberian, Sally Lindsay
Honey, Jay Kehoe, Matt Knighton, Shawn O'Neill, Sarah Renz, and Ronald White

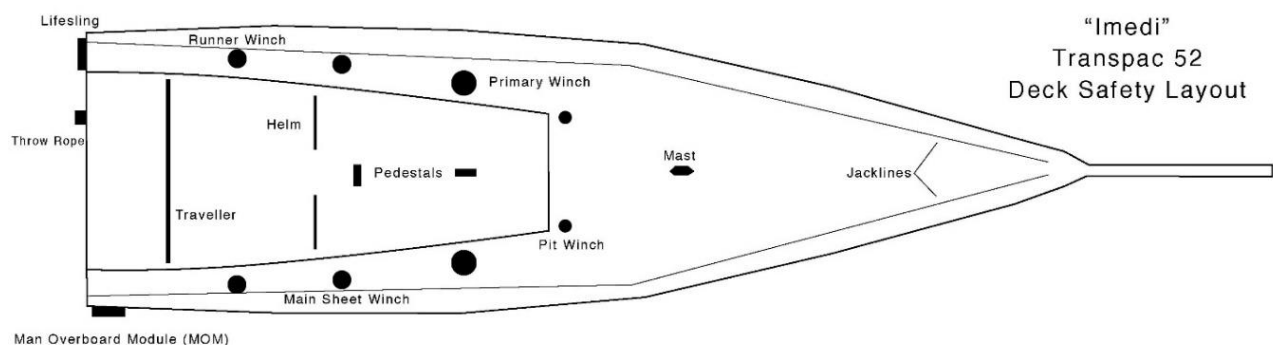
Figure 2: *Imedi* Jacklines- Hydraulic vang controls were on centerline between the wheels

3.2. The TP 52 has a large open cockpit, with the vang control located far aft (behind the steering wheels in the center of the deck) and remote from likely handholds and jacklines.

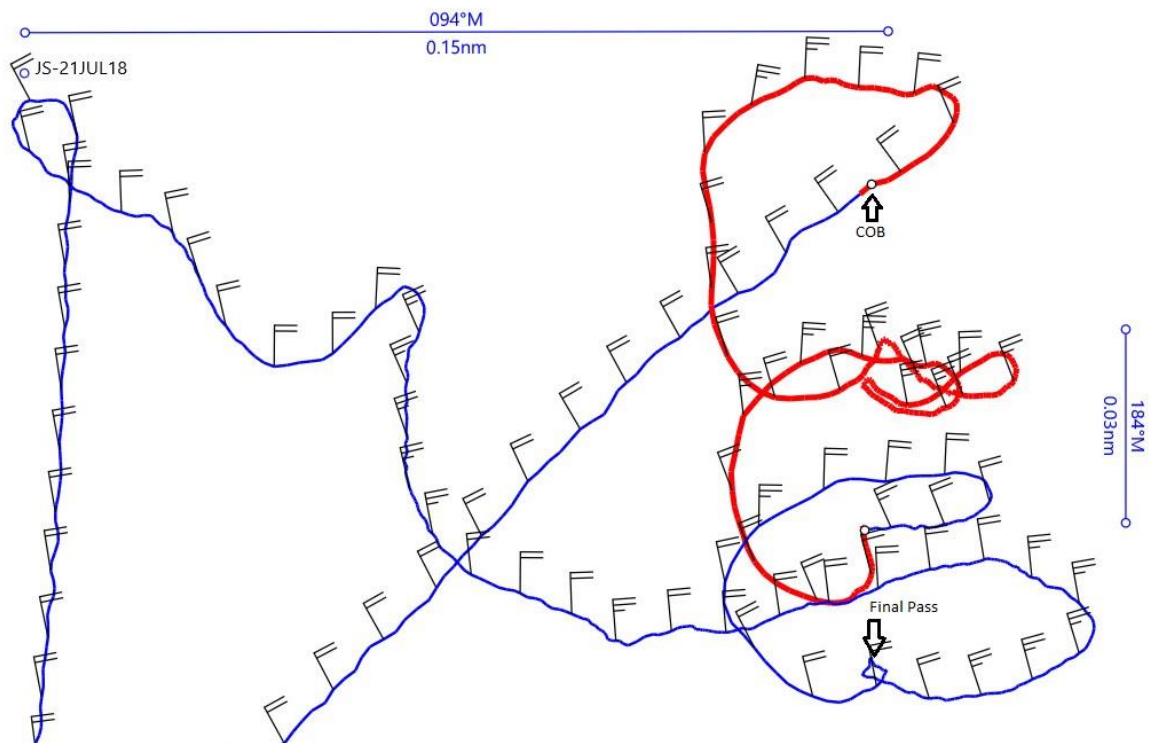
Figure 4: MOB recovery attempt track from approximately 14:24:45 to 14:41:52

6.10.3. In a subsequent interview, the driver demonstrated with props how on all three passes, the boat tacked away onto starboard tack, sailed down below Jon, gybed, and then went head-to-wind with Jon on the starboard side of the boat in an attempt to pass as close as possible to him. Others had conflicting memories of their maneuvers (certain crew reported that Jon was off the port side which may be the result of where and when they observed Jon as the boat maneuvered back to him).

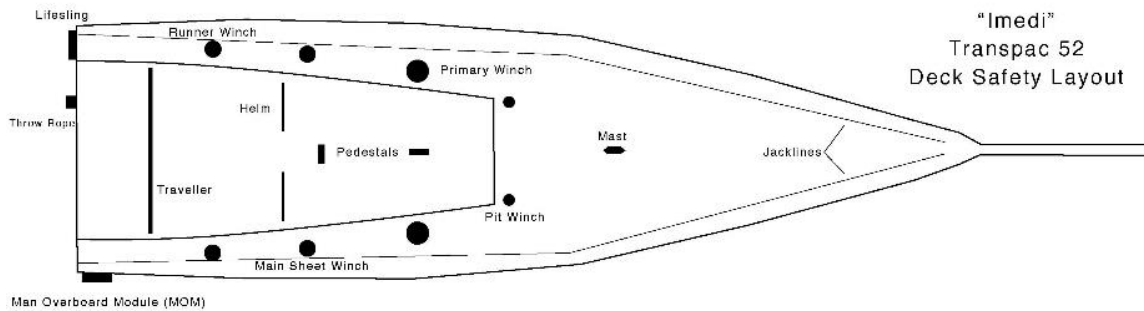
Figure 5- Imedi Deck Layout: Hydraulic vang controls were on centerline between the wheels

The TP 52 has a large open cockpit, with the vang control located far aft and remote from likely handholds and jacklines.

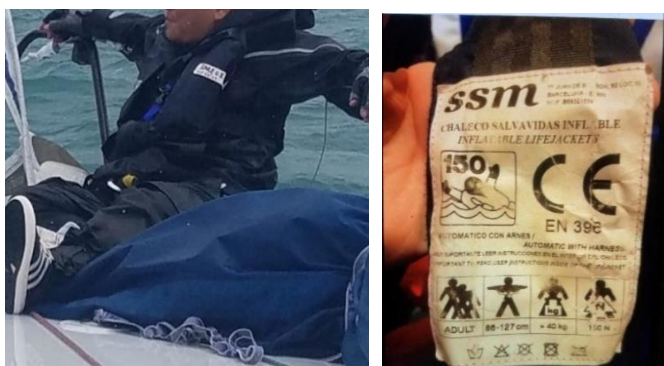
Figure 7 Boat-issued life Jacket and life jacket label

All reports are consistent that Santarelli was wearing an inflatable life jacket at the time he went overboard, and it did not inflate. Nor is there any indication that the manual pull or the oral inflator was attempted to be utilized by him. Had the life jacket inflated, there would have been considerable additional time to effectuate a retrieval of him once he went overboard.

The Hammar MA1 inflator is a hydrostatic type inflator that is utilized in a number of different brands of inflatable life jackets. Based upon interviews with the crew, the life jackets came with the boat, and thus could be as much as 12-13 years old. Whether the inflator mechanism in the jacket Santarelli was wearing had ever been replaced is unknown.

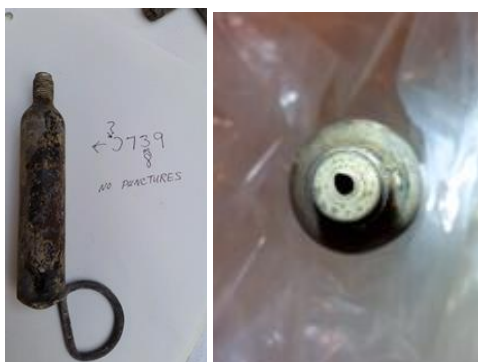
Santarelli's body was recovered on Saturday, July 28, which was one week after he had gone overboard. Upon being advised of the recovery, the Chicago Yacht Club (CYC) promptly asked the Coast Guard to determine whether in fact he was wearing a life jacket and whether it was operational. The Coast Guard advised CYC on Monday, July 30, based on their conversations with the Medical Examiner's Office, Santarelli was wearing his life jacket but that it had not inflated.

Figure 8 CO₂ Inflation cylinder from Jon's life jacket showing it had not been pierced prior to the incineration
