Review Committee Report on the
Fatal Accident Involving *Imedi*
During the 2018 Chicago Yacht Club Race to Mackinac
on July 21, 2018
Published: February 25, 2019

Committee Members: Christopher Thomas, chair, Nick Berberian, Sally Lindsay
Honey, Jay Kehoe, Matt Knighton, Shawn O'Neill, Sarah Renz, and Ronald White

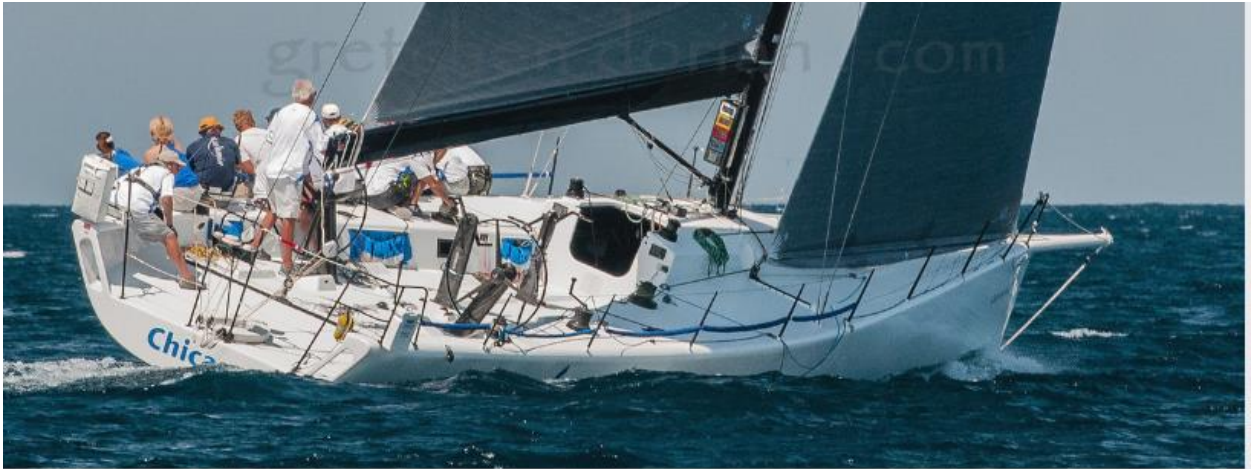
The TP 52 has a large open cockpit, with the vang control located far aft and remote from likely handholds and jacklines.
